North 56th Street and Arbor Road Substandard and Blight Determination Study

Lincoln, Lancaster County, Nebraska

Prepared for: the City of Lincoln, Nebraska

August, 2005

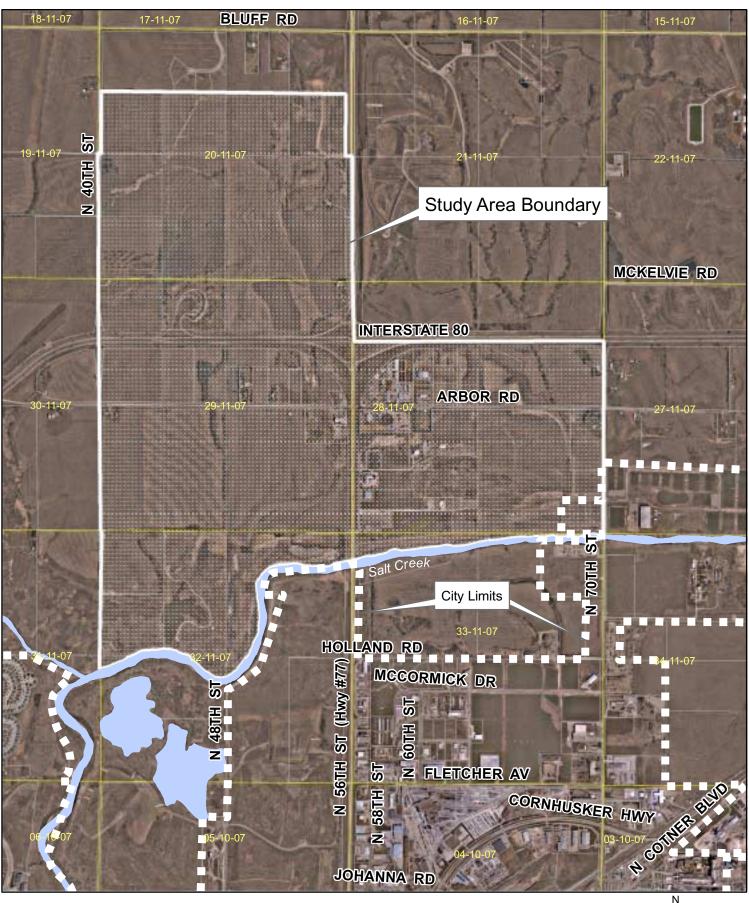
Map 2: Study Area Boundary

Beginning at Salt Creek, north on North 40th Street to a point approximately one mile north of Interstate 80, then east to US Highway 77, then south to the Interstate, then east to North 70th Street, then south to Salt Creek, and then in a south/southwest direction following Salt Creek to the starting point.

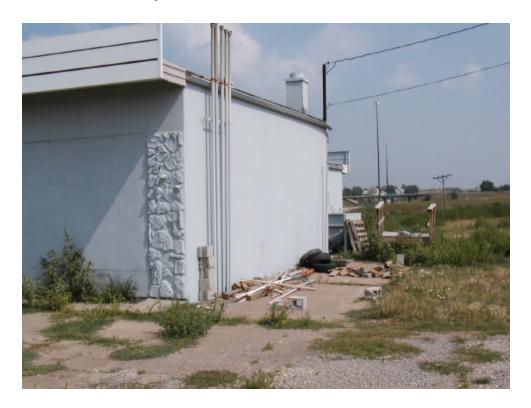
Commercial/Industrial Structures: There are 15 commercial-type structures in the study area. The oldest, an abandoned service station located at the southeast corner of I-80 and North 56th Street was built in 1964 (followed five years later by another station at the southwest corner). The abandoned service station (see picture below) is essentially obsolete and has fallen into a state of disrepair. With the exception of the service stations and the Highway Rest Area located westbound along the Interstate, all non-residential buildings are warehouse-type structures, almost exclusively metal, of average-to-good condition. These buildings were primarily constructed during the 1990s, however a large commercial structure was constructed as recently as 2003 in the study area. The average age of these non-residential structures is 12 years.

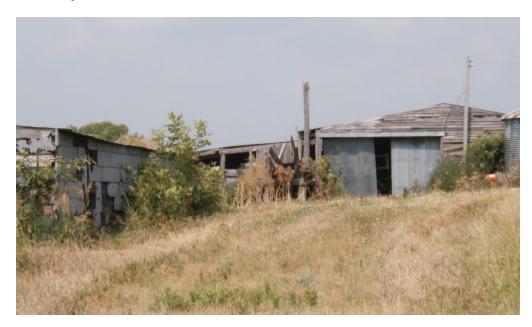
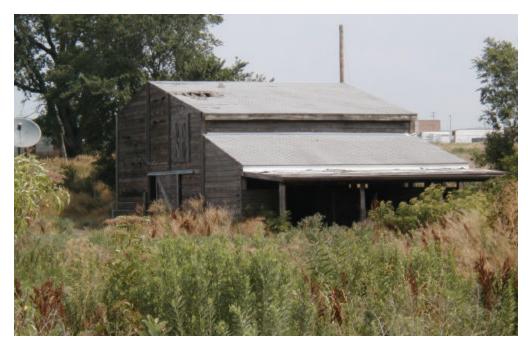
<u>Secondary Structures</u>: In addition to the commercial buildings existing in the study area, there are 31 secondary structures located in the study area. Almost all of these serve as auxiliary buildings to residential uses, including former farmsteads. The Lancaster County Assessor lists 23 of these structures in their records, with an average age of 50 years. Three of these structures, in addition to the 8 not reported on the County Assessor's property records are in an advanced state of disrepair or neglect, with structural defects that are serious enough or extensive enough to warrant their removal. It can be assumed that the buildings not shown in the County Assessor's record were constructed at the same time of the homes near them. Using this age as a guide places the average age of all secondary structures at 62 years.

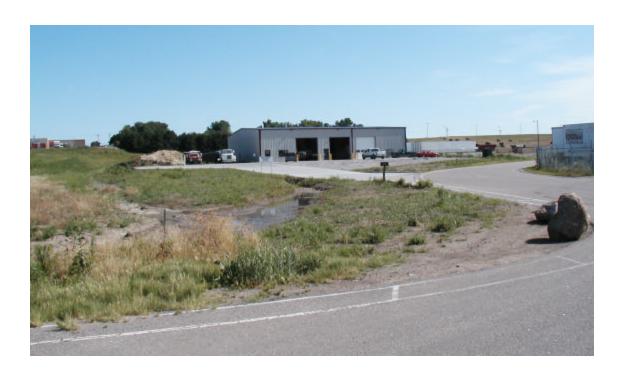
Private Roadways: are located in the southeast quadrant of the study area to provide access to businesses on interior parcels. There are two unplatted private drives ending in cul-de-sacs running north from Arbor Road, and two running east-west ending in cul-de-sacs accessed off of North 56th Street. Although paved, as shown in the photograph below, they do not conform to city standards.

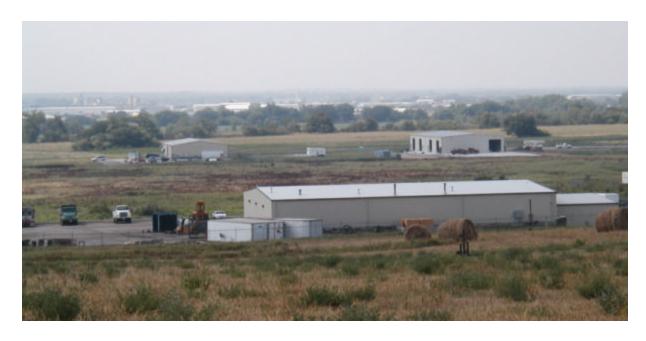
The map on the following page shows the ownership parcels that have been created in the study area. As shown, the area contains 66 individual ownership parcels ranging in size from less than one acre to 160 acres. The map also shows the location of parcels without frontage on a public street or roadway. There are 50 different ownership entities with property in the study area. Landowners include both public (State Department of Roads, City of Lincoln, Lower Platte South Natural Resources District, and State Board of Education Lands and Funds) and private entities. The ownership diversity and patterns, as well as the unusual condition of condominium ownership of land parcels, complicates assemblage of land for redevelopment purposes.

In the southwest and southeast quadrants of the study area, land has been divided into smaller parcels for the purposes of sale and development. All of this parceling has occurred without the review and approval by the city in accordance with subdivision regulations (Title 26 of the Lincoln Municipal Code). The result (see picture below) has been piecemeal development, the creation of oversized lots and irregularly shaped parcels, parcels without adequate consideration for proper design, drainage, or future streets and utilities, interior lots without access to public streets, residential uses mixed in with commercial/industrial uses, and businesses without street addresses reflective of their location. In the west half of the southeast quadrant, this type of land development is especially prevalent. Here, land is being developed under condominium ownership regimes, which essentially enable property owners to subdivide land (and sell parcels) of less than ten acres without subdivision review. There are four condominium regimes in this area, although one of these has been properly recorded as a subdivision (Parrott's Addition).

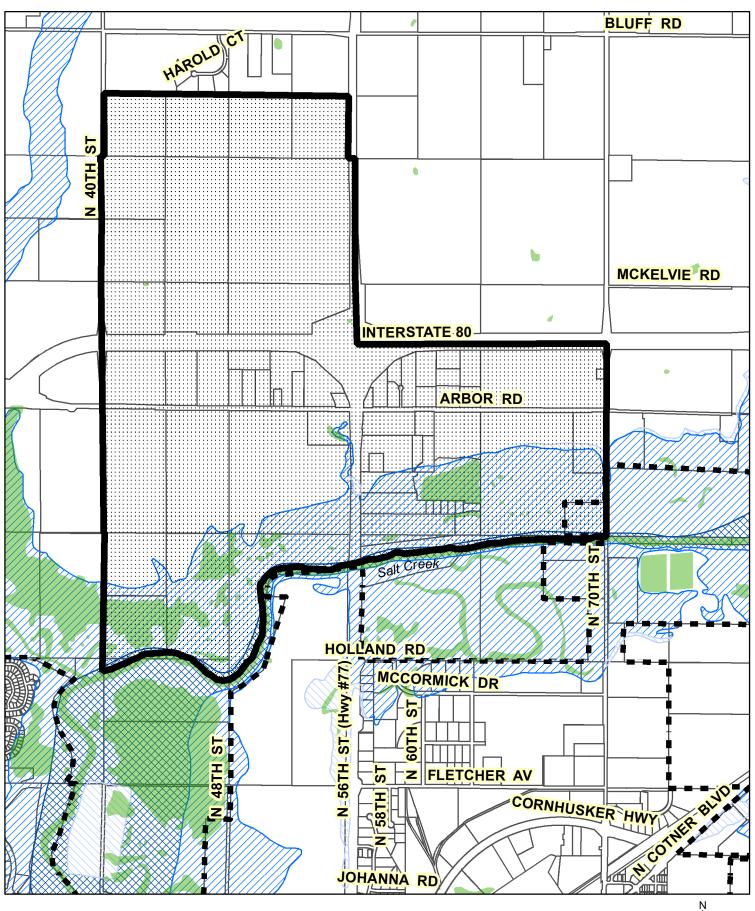
Map 5: Floodplain and Wetlands North 56th Street & Arbor Road Blight Study

Additional concerns are the presence of septic systems within the 100-year floodplain. At least three of the systems are within the 100-year floodplain of Salt Creek. The map on the following page shows the location of the floodplain in this area.

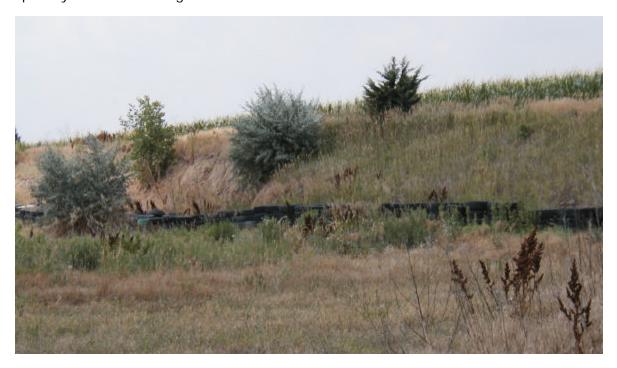
<u>Outdoor tire storage:</u> Two businesses in the area store truck tires--new or used--outdoors on their properties. In the southwest quadrant of the study area, used tires are stacked along most of the west perimeter and about one-third of the south perimeter of a 14.47 acre parcel, forming a line of stacked tires approximately 800 feet long (see picture below). These tires are located around a wetland area and provide an ideal breeding ground for mosquitoes. Additionally, the tires on this parcel are generally surrounded by overgrown vegetation, which provide an extremely dangerous situation in the case of grass fires, especially in times of drought.
